**Flood Control Project Maintenance
Levee Inspections**
LMA District Cover Sheet
Spring 2020 Levee Inspection Results

Lower San Joaquin Levee District

Spring 2020 Levee Inspection Results

Waterway			Bank	Unit Miles
Unit No. 01 San Joaquin River			Right	22.52
	Spring (March - May)	Summer (June - August)	(September - November) Fall	Winter (December - February)
Unit Maintenance Rating (Fall Only)				
Date of Inspection	4/21/2020 - 4/21/2020			
DWR Inspector	Corey Fujitani			
Accompanied By

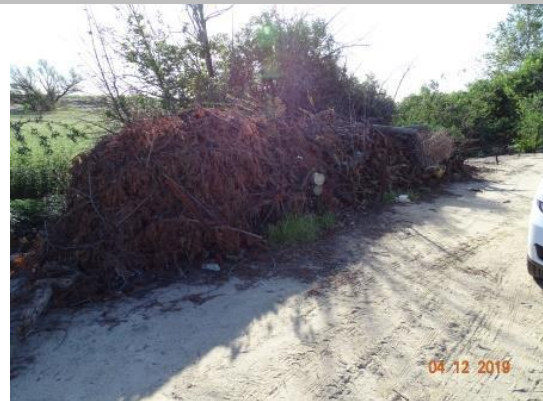
Photo 1 of 1 : SP_2020_NA0010_140_19_20200225_00006.jpg

LM Start	7.38	Rating **	M	Issue No.	19
LM End	7.38	Issue Type +	En	Location *	WS
Category	Earthen Levee			GPS Latitude/Longitude	
				Start	End
Item	Encroachments			36.778838 °	36.778838 °
				-120.198478 °	-120.198478 °
DWR ID	DWR_NA0010_24_s_2019_19				
Comment Code					
TR : Tree or limb					
Inspector Comment

View of tree punings left on waterside shoulder. (Spring 2019)

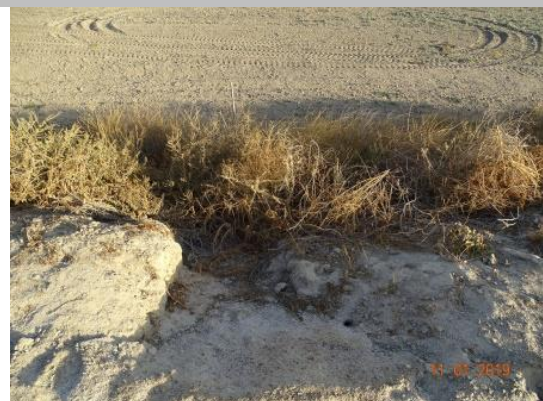
Photo 1 of 1 : SP_2020_NA0010_140_11_20200225_00004.jpg

LM Start	7.83	Rating **	A/W	Issue No.	11
LM End	7.83	Issue Type +	Ma	Location *	WS
Category	Earthen Levee			GPS Latitude/Longitude	
				Start	End
Item	Erosion / Bank Caving			36.775271 °	36.775271 °
				-120.192400 °	-120.192400 °
DWR ID	DWR_NA0010_24_f_2019_11				
Comment Code					
E1 : Note and monitor erosion site.					
Inspector Comment

Looking East down the waterside slope. (Fall 2019)

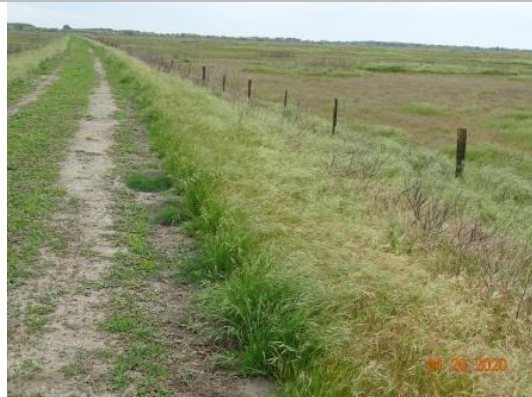
Photo 1 of 1 : SP_2020_NA0010_141_9_20200514_00022.jpg

LM Start	0.00	Rating **	U	Issue No.	9
LM End	2.47	Issue Type +	Ma	Location *	WS
Category	Earthen Levee			GPS Latitude/Longitude	
				Start	End
Item	Vegetation			37.296306 °	37.271279 °
				-120.880674 °	-120.866679 °
DWR ID	DWR_NA0010_25_s_2020_9				
Comment Code					
V1 : Control annual grass and weeds on the levee slopes and easements.					
Inspector Comment

Looking upstream along the waterside slope. (Spring 2020)

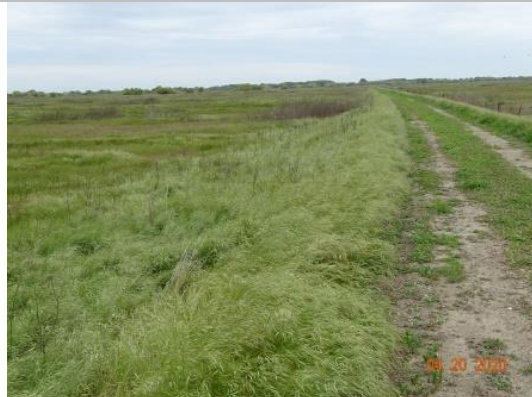
Photo 1 of 1 : SP_2020_NA0010_141_7_20200514_00024.jpg

LM Start	0.00	Rating **	U	Issue No.	7
LM End	2.47	Issue Type +	Ma	Location *	LS
Category	Earthen Levee			GPS Latitude/Longitude	
				Start	End
Item	Vegetation			37.296305 °	37.271278 °
				-120.880674 °	-120.866679 °
DWR ID	DWR_NA0010_25_s_2020_7				
Comment Code					
V1 : Control annual grass and weeds on the levee slopes and easements.					
Inspector Comment

View of the landside slope looking upstream. (Spring 2020)

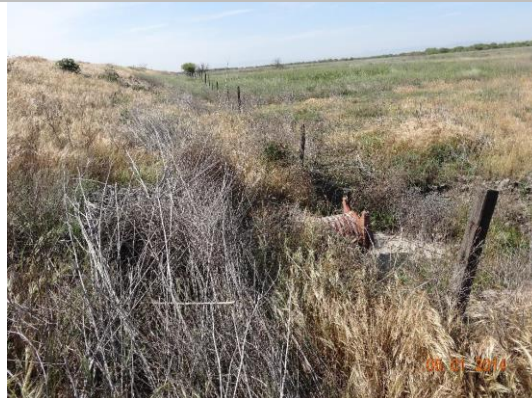
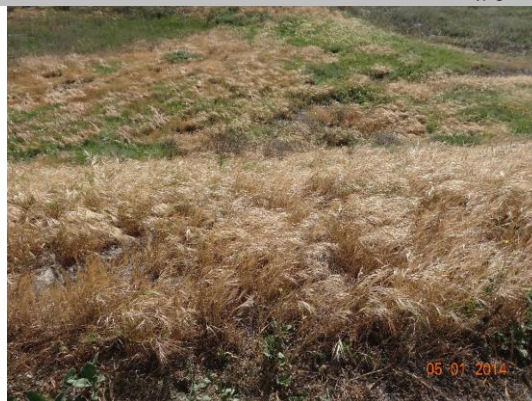
Comment Code						
Inspector Comment						
DS_ID:19965 FS_ID:39501 EP_NO: N/A Repair Type: Non-Urgent Crossing Status: Found UCIP Comments: 05/01/2014 Dense vegetation limits the inspectors visibility to identify signs of pipe failure (leaks) along the slope. Recommend removing vegetation along pipe alignment to conduct proper inspection of structure. Sediment buildup in pipe visible from landward side--recommend clearing. (DWR UCIP - O. Magana) FIELD_STRUCT_DESC: 24-inch corrugated metal gravity drainage pipe through the levee, 10 feet below the crown. Flap gate on the waterside (WS) end. [Additional Reference(s): DWR Levee Log, 2002. USACE San Joaquin O&M Manual 601.1, 1967, (HLM 0.02)]. FS Date: 5/1/2014

View of waterward side--dense vegetation on waterward side.

Pipe daylight visible on waterward toe.

View of landward side--dense vegetation on landward side.

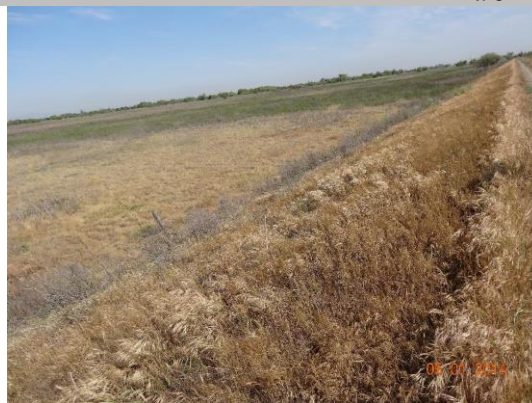
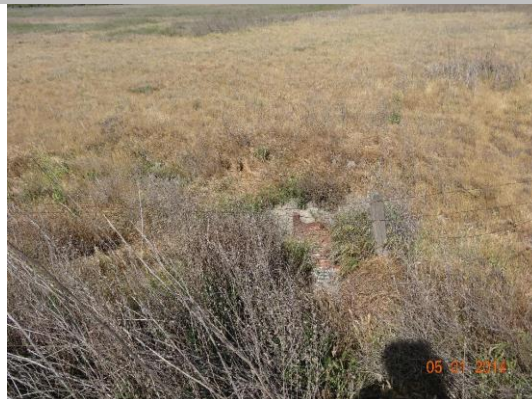
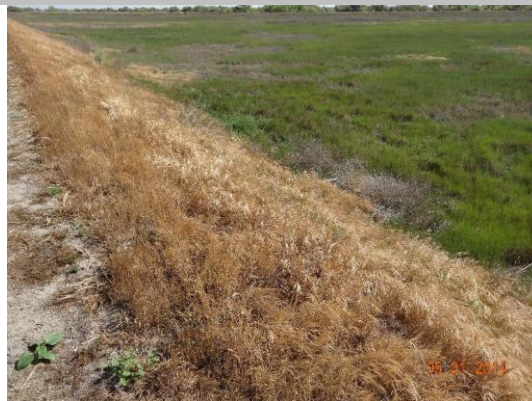
DS_ID:19966
 FS_ID:36851
 EP_NO: N/A
 Repair Type: Non-Urgent
 Crossing Status: Found
 UCIP Comments: 05/01/2014 Dense vegetation limits the inspectors visibility to identify signs of pipe failure (leaks) along the slope. Recommend removing vegetation along pipe alignment to conduct proper inspection of structure. (DWR UCIP - O. Magana)
 FIELD_STRUCT_DESC: 24-inch corrugated metal gravity drainage pipe through the levee, 11.6 feet below the crown. Flap gate on the waterside (WS) end. [Additional Reference(s): DWR Levee Log, 2002. USACE San Joaquin O&M Manual 601.1, 1967, (HLM 0.35)].
 FS Date: 5/1/2014

View of waterward side.

Pipe outlet visible on waterward side.

View of landward side.

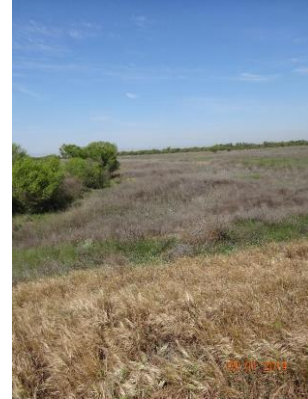
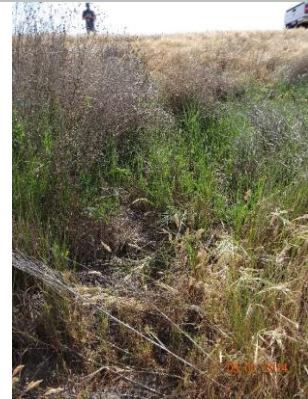
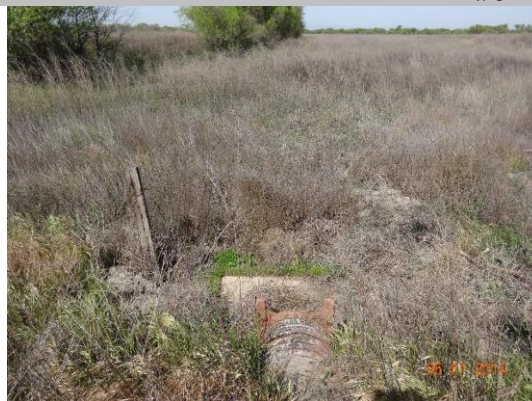
Comment Code						
Inspector Comment						
DS_ID:19967						
FS_ID:36852						
EP_NO: N/A						
Repair Type: Non-Urgent						
Crossing Status: Found						
UCIP Comments: 05/01/2014 Dense vegetation limits the inspectors visibility to identify signs of pipe failure (leaks) along the slope.						
Recommend removing vegetation along pipe alignment to conduct proper inspection of structure. (DWR UCIP - O. Magana)						
FIELD_STRUCT_DESC: 24-inch corrugated metal gravity drainage pipe through the levee, 14.7 feet below the crown. Flap gate on the waterside (WS) end. [Additional Reference(s): DWR Levee Log, 2002. USACE San Joaquin O&M Manual 601.1, 1967, (HLM 0.59)].						
FS Date: 5/1/2014

Overview of waterward side--Salt Slough.

View of waterward slope covered by dense vegetation.

Pipe and flap gate visible on waterward side.

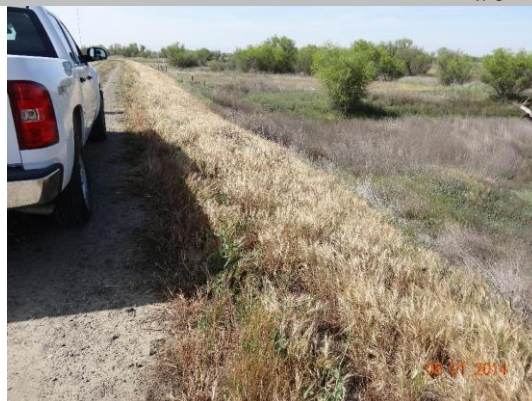
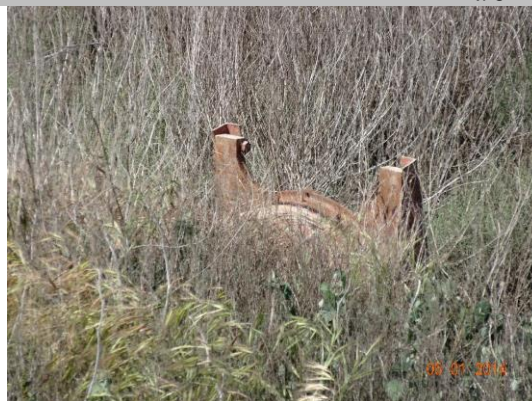
DS_ID:19968
 FS_ID:36853
 EP_NO: N/A
 Repair Type: Non-Urgent
 Crossing Status: Found
 UCIP Comments: 05/01/2014 Dense vegetation limits the inspectors visibility to identify signs of pipe failure (leaks) along the slope. Recommend removing vegetation along pipe alignment to conduct proper inspection of structure. (DWR UCIP - O. Magana)
 FIELD_STRUCT_DESC: 24-inch corrugated metal gravity drainage pipe through the levee, 11.4 feet below the crown. Flap gate on the waterside (WS) end. [Additional Reference(s): DWR Levee Log, 2002. USACE San Joaquin O&M Manual 601.1, 1967, (HLM 0.97)].
 FS Date: 5/1/2014

View of waterward side.

Pipe and evidence of flap gate visible on waterward side.

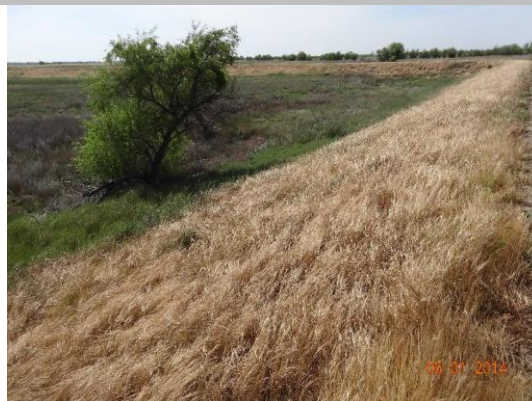
Photo 3 of 3 : UCIP_SP_2020_36853_67254.jpg

View of landward side.

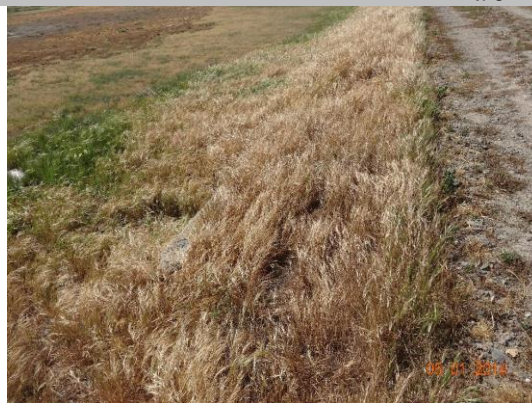
Photo 1 of 3 : UCIP_SP_2020_36854_67259.jpg

LM Start	2.05	Rating **	M	Issue No.	19
LM End	2.05	Issue Type +	Ma	Location *	
Category	Supplemental			GPS Latitude/Longitude	
				Start	End
Item	DWR UCIP LMA Responsibility			37.277390 °	37.277390 °
				-120.867184 °	-120.867184 °
DWR ID	19969				
Comment Code					
Inspector Comment					
DS_ID:19969 FS_ID:36854 EP_NO: N/A Repair Type: Non-Urgent Crossing Status: Found UCIP Comments: 05/01/2014 Dense vegetation limits the inspectors visibility to identify signs of pipe failure (leaks) along the slope. Recommend removing vegetation along pipe alignment to conduct proper inspection of structure. (DWR UCIP - O. Magana) FIELD_STRUCT_DESC: 24-inch corrugated metal gravity drainage pipe through the levee, 4 feet below the crown. Flap gate on the waterside (WS) end. [Additional Reference(s): DWR Levee Log, 2002. USACE San Joaquin O&M Manual 601.1, 1967, (HLM 2.05)]. FS Date: 5/1/2014

View of landward side.

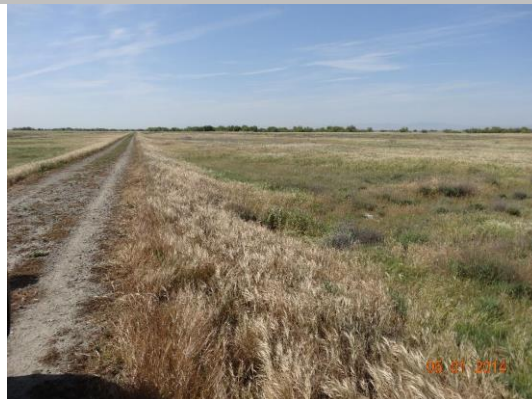
Photo 2 of 3 : UCIP_SP_2020_36854_67260.jpg

View of waterward side.

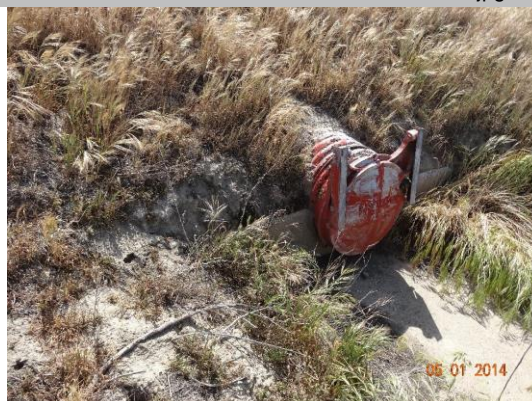
Photo 3 of 3 : UCIP_SP_2020_36854_67261.jpg

Flap gate and concrete headwall located on waterward toe.

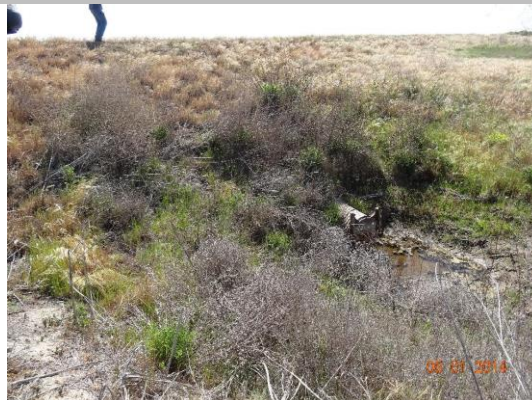
Photo 2 of 3 : UCIP_SP_2020_39502_67269.jpg

Pipe daylights at waterward toe.
